Parking Equity: Detering Access Aisle Parking Violations

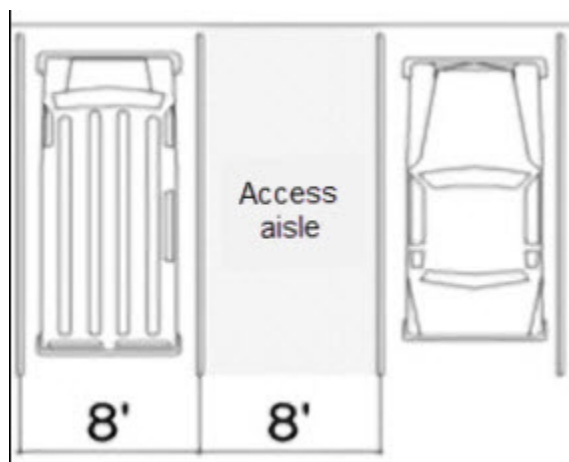
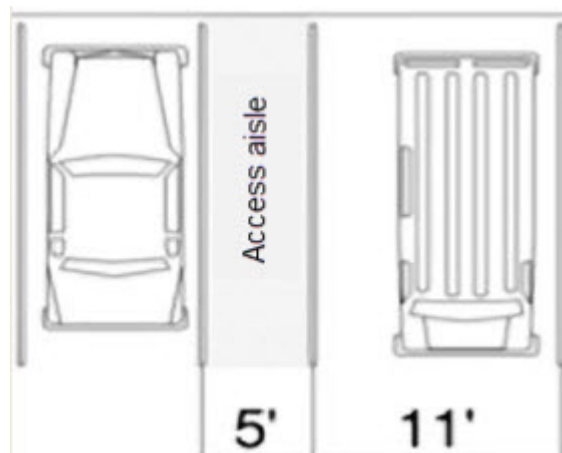
Van-accessible parking layout options:

Van-accessible parking spaces provide enough room for a person who uses a ramp- or lift-equipped vehicle (RLEV) to lower the ramp/lift so that a wheelchair user can safely enter and exit the vehicle. Ramps and lifts usually lower on the right (passenger) side of the vehicle, though some vans have a ramp/lift in the back. Two van-accessible layouts are acceptable according to the 2010 Americans with Disability Act (ADA) standards (*see illustration below*). Both options total 16 feet:

- An 8-foot accessible parking space with an adjacent 8-foot access aisle.
- An 11-foot accessible parking space with an adjacent 5-foot access aisle.

8' plus 8'

OR

11' plus 5'

required to have an 8-foot accessible parking space with an adjacent 5-foot access aisle (13 feet total). Standard access aisles accommodate people with disabilities who use wheelchairs, walkers, and other assistive devices by providing the needed extra space to enter and exit their vehicles.

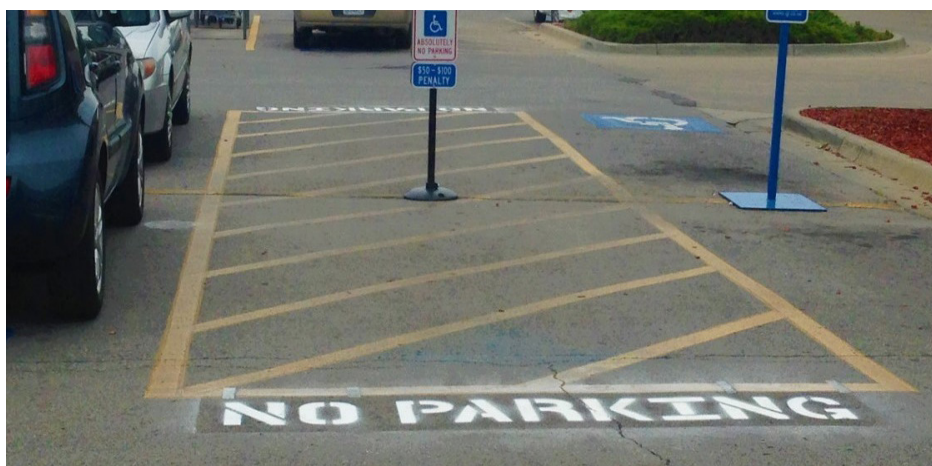
For Quantitative Study One, the researchers added signs and “No Parking” pavement markings to the access aisles at one site. This access aisle warning sign is patterned on South Dakota’s.

We conducted experimental studies at two sites, both grocery stores, in a mid-sized Midwestern city. The first experimental study at Site I tested the effectiveness of “No Parking in Access Aisle” signs combined with “No Parking” pavement markings.

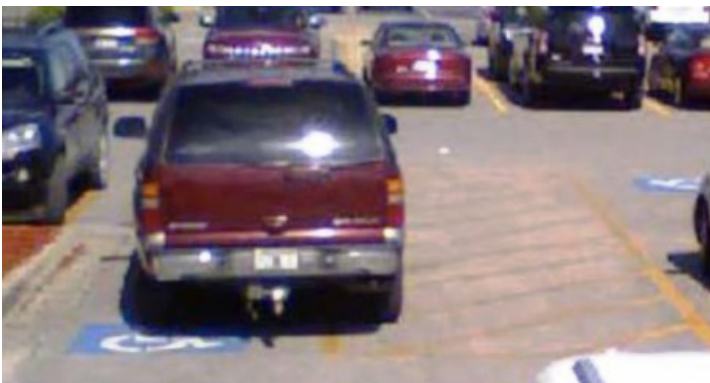
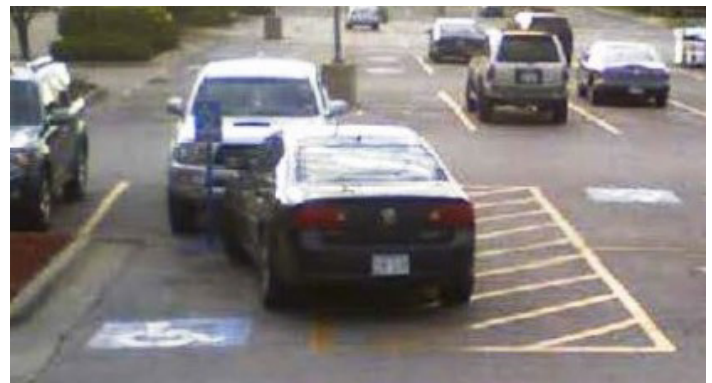
The researchers photographed access aisle violations at the sites and categorized them by the amount of space the vehicles encroached upon. These photos show moderate (left) and severe (right) violations, which make the aisle difficult for others to use, especially if using a ramp or lift. .

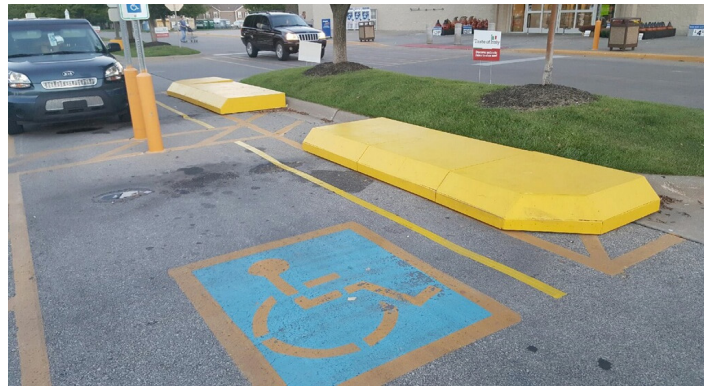
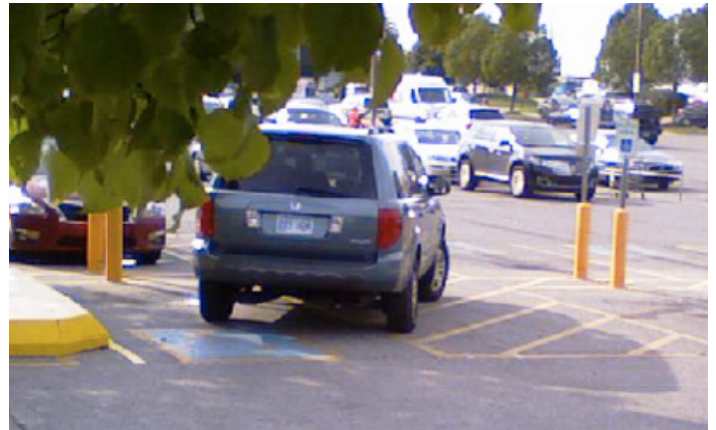
For Quantitative Study Two, the researchers built a temporary curb (the yellow platform) to cover the “courtesy aisle” so that the accessible parking spaces at Site 2 were similar to those at Site 1. This prompted some unique parking strategies, as pictured above.

layout at this site contributes to the low instances of access aisle parking violations. In addition to the standard access aisle on the passenger side of this 9'8" wide parking space, there was also a 4-foot-wide diagonally striped "courtesy aisle" on the driver's side, adjacent to the curb. This extra room may be responsible for deterring access aisle parking violations in this space.

Research Methods: In order to test this hypothesis, the researchers obstructed the extra space offered by the courtesy aisle to test the effects of the remaining layout on deterring access aisle parking violations. They built a temporary curb to make the accessible parking spaces at Site 2 similar in width to those at Site 1.
